Guidelines for
**Preservation, Stewardship
& Development**

Guidelines for the
Preservation, Stewardship, and Development
of the
Dimock Community Health Center Campus
55 Dimock Street
Roxbury, Massachusetts

Prepared by August Associates, Architects
under contract with
Historic Boston Incorporated
with partial financial support through the
Boston Landmarks Commission
from the City of Boston
Neighborhood Development and Employment Agency
Community Development Block Grant funds.

November 1984

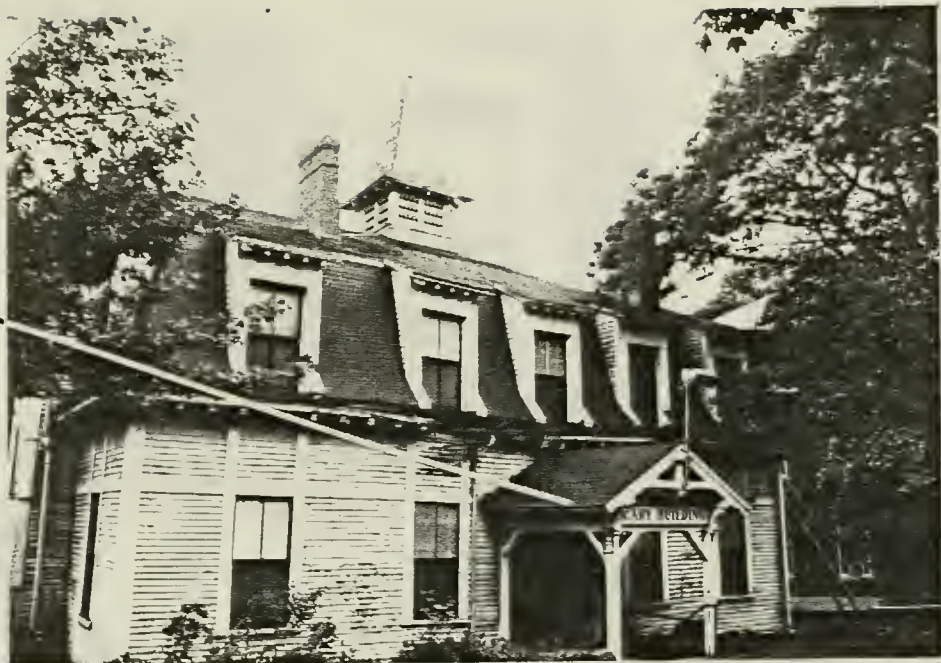
1

Tudor stick style
Porte-Cochere

Fire escape

<u>Area of Work Arranged in Order of Priority; & Photo Key</u>	<u>Estimated Cost</u>	<u>Maintenance & Scheduling</u>
1. Reroof main roof, cupola, dormers and porte-cochere. (Photos # 1, 2, 3, 5, 6, 9)		New roof lasts 15-20 yrs

6. Remove exterior flood light from porte-cochere gable end. (Photos # 1, 2)		N/A
7. Replace front hand rail with more compatible style. (Photos # 2, 4)		Paint every 4-6 yrs

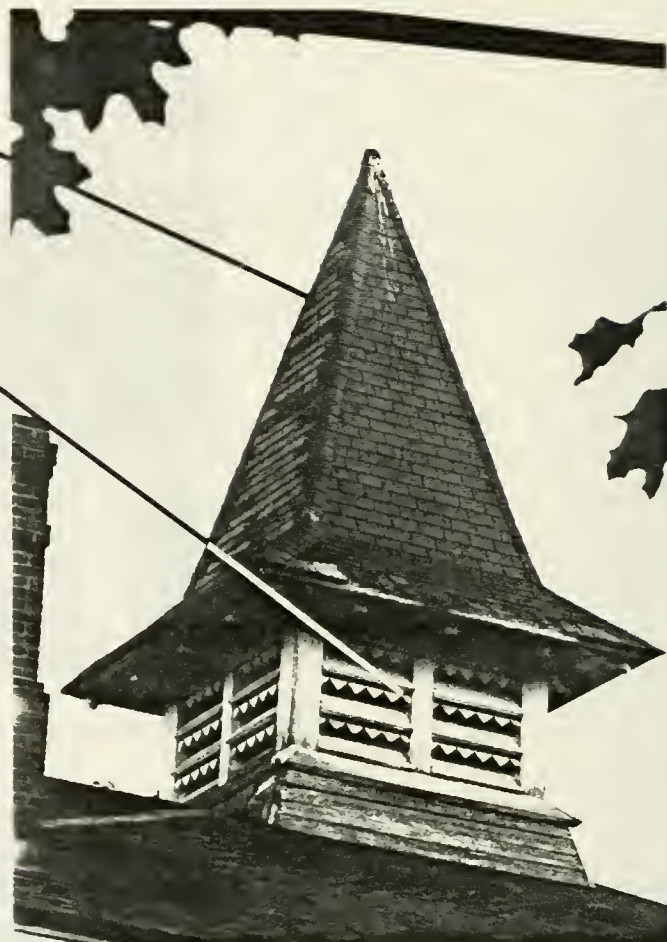
3

Pyramid shaped roof cupola

Sawtooth louvers

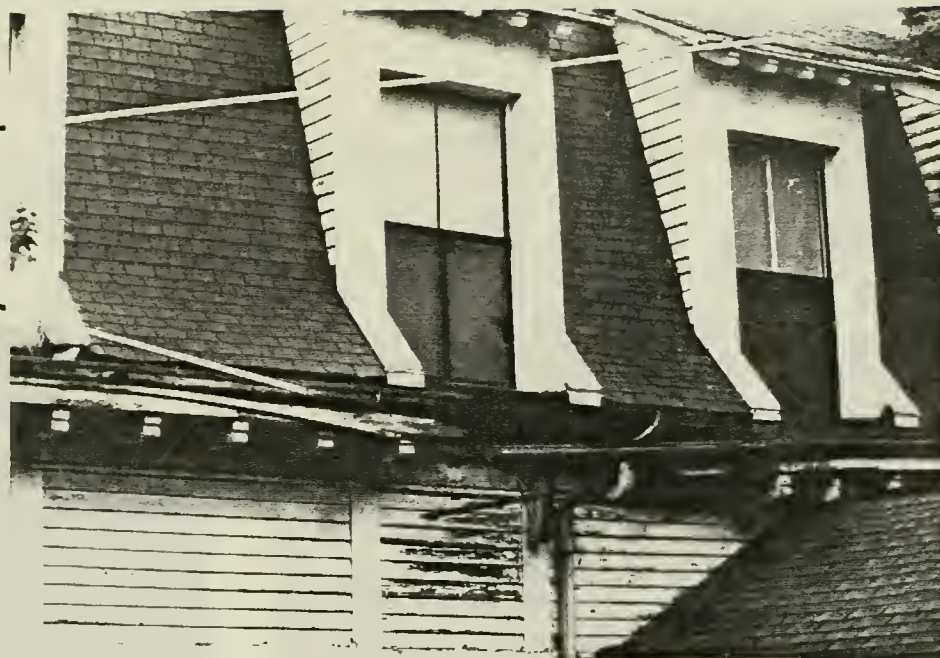
5

Shed dormer

Wooden gutter

2. Restore wooden gutters, sup- porting brackets, fascia, sof- fit area and downspouts. (Photos # 1, 5, 6, 7, 9, 10)		Repaint every 4-6 yrs. Clean gutters every spring and fall

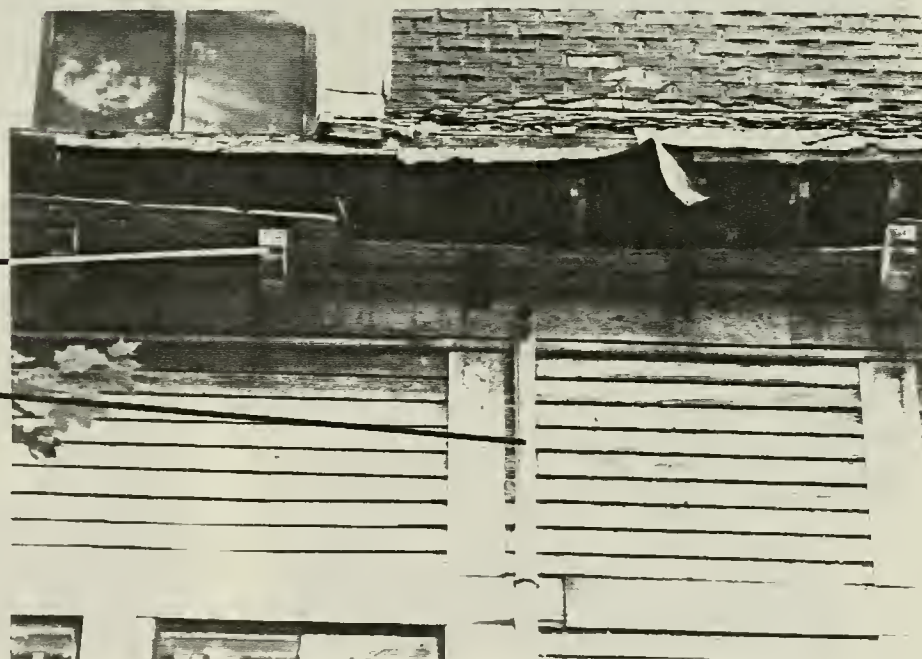
6

Brackets

Downspout

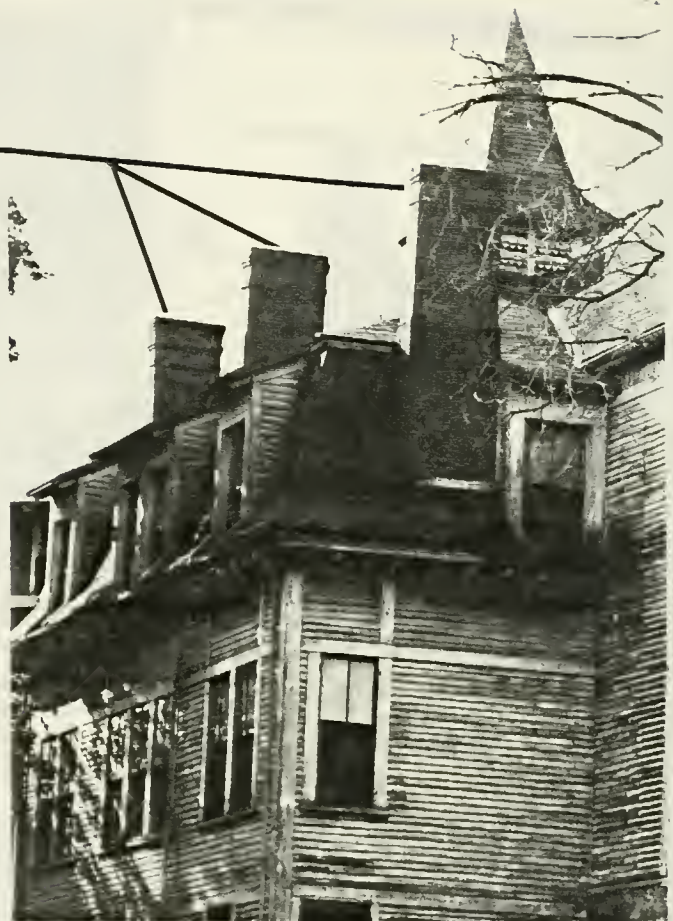
7

Brick detailed chimneys

3. All exterior wood surfaces need to be repaired, scraped and sanded, restored, or replaced. (Photos # 1, 2, 3, 4, 5, 6, 7, 8, 9, 10)		Paint every 4-6 yrs

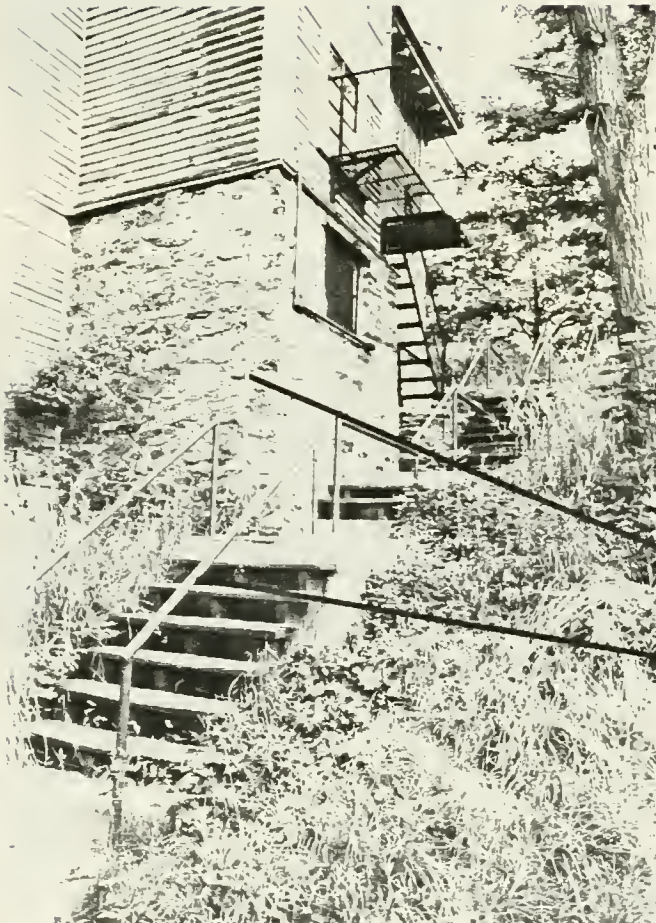
8

Puddingstone foundation wall

4. Remove all loose, mismatched unsound mortar and masonry from chimneys and foundations. Repoint, repair and replace as necessary to retain original character. (Photos # 2, 8, 9, 10)		Check and and repair every 10-15 yrs

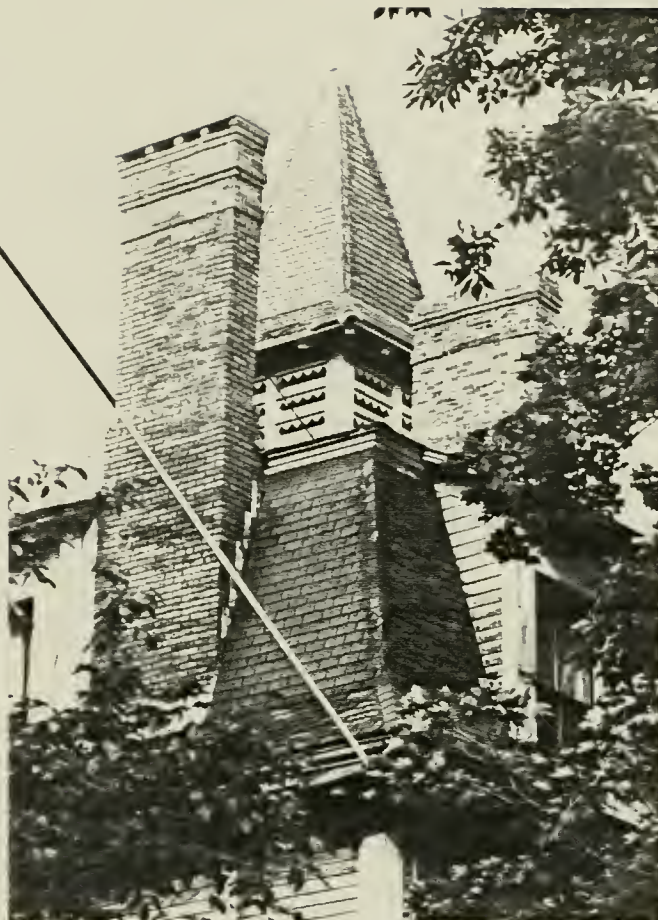
9

Damaged gutter and brackets

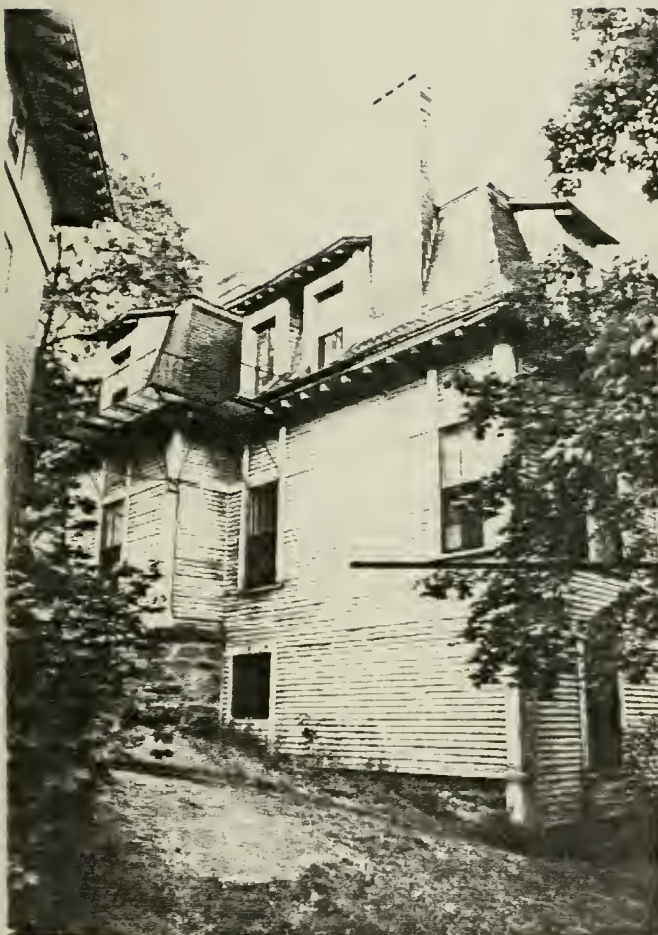
10

Clapboard siding

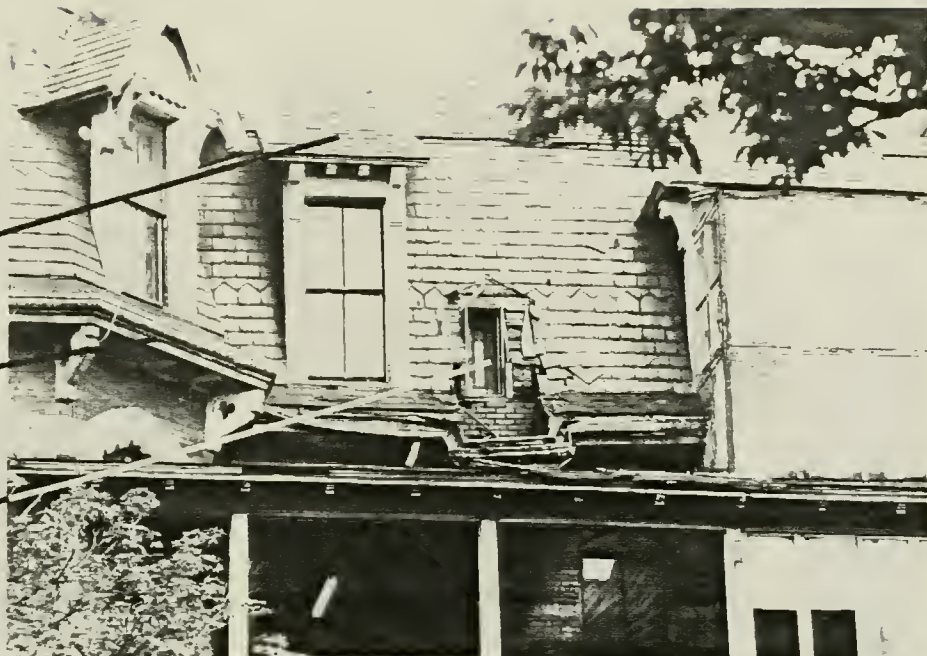
19

Wooden gutter and brackets

Missing Spire
(Stored at Dimock)

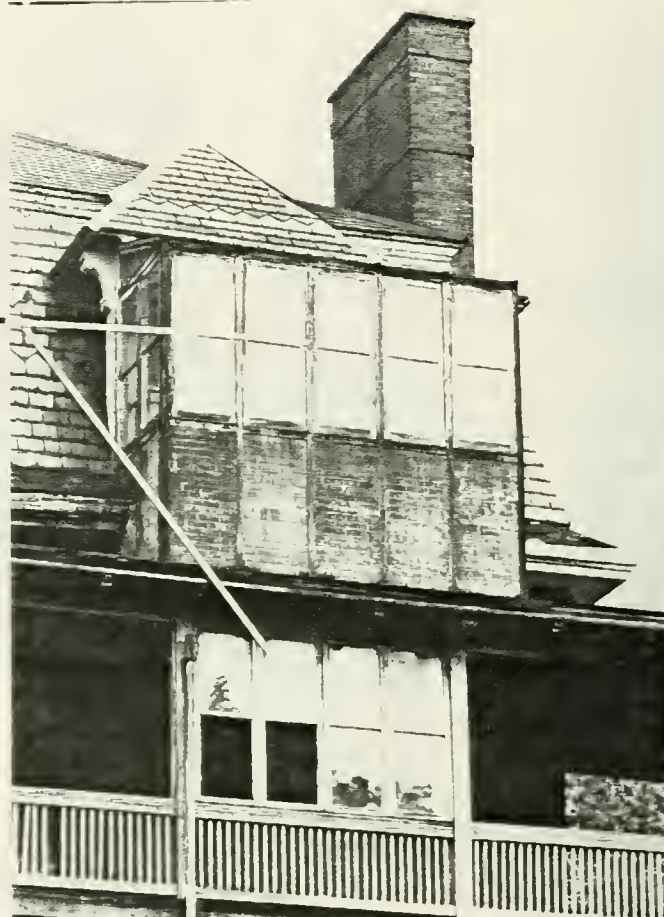
21

Added sun rooms, to be removed

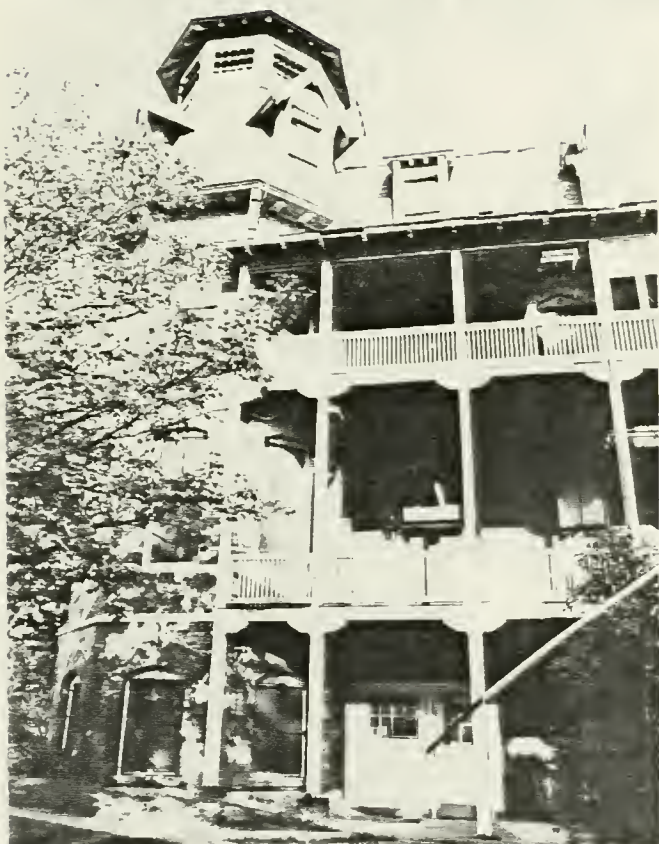
22

Shed storage, to be removed

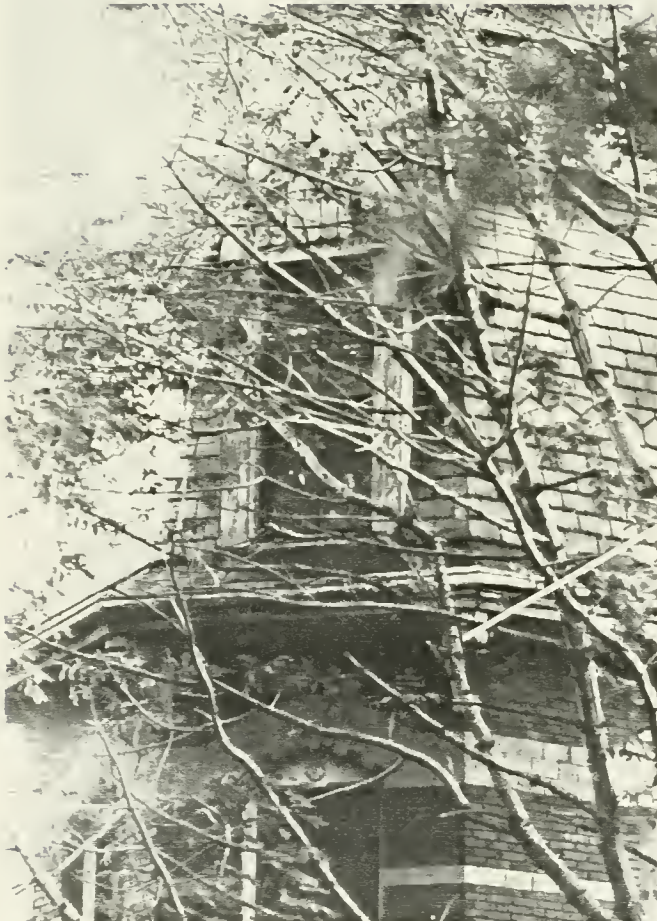
30

Wooden gutter and bracket in need of restoration

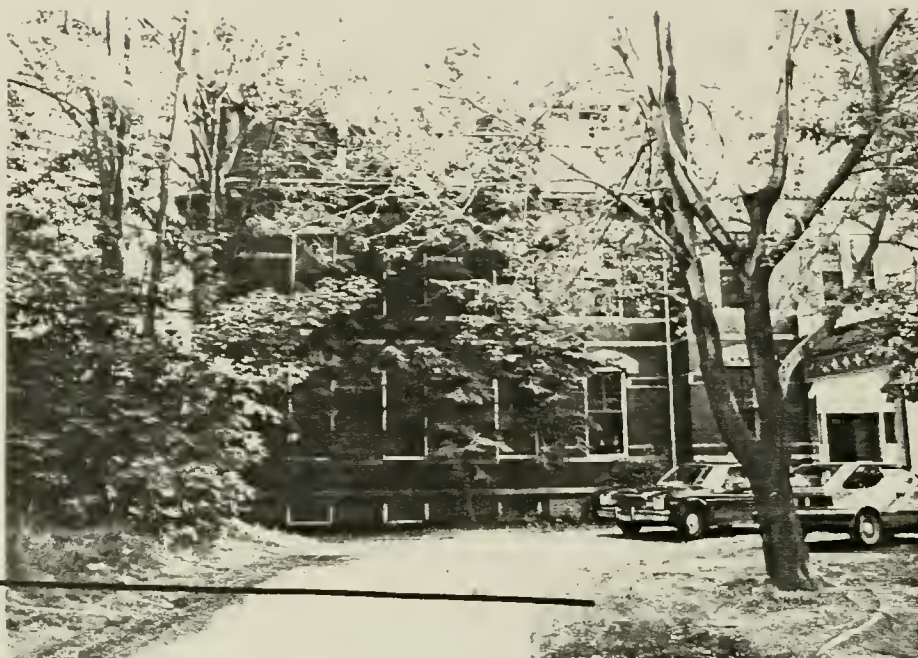
31

grass planting and curbs
needed

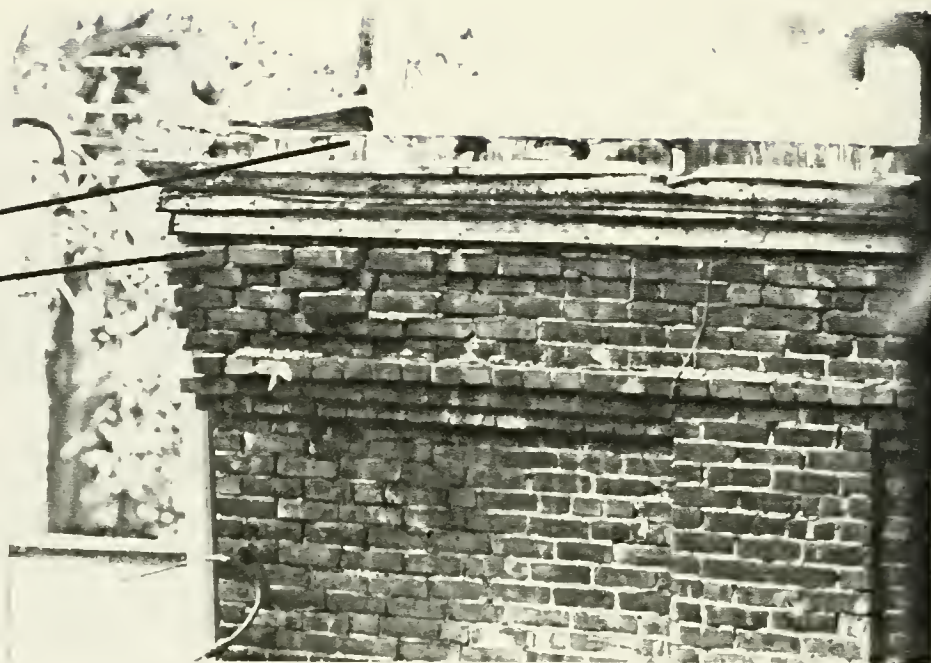
34

Repair roof water drainage
system

Brick cornice

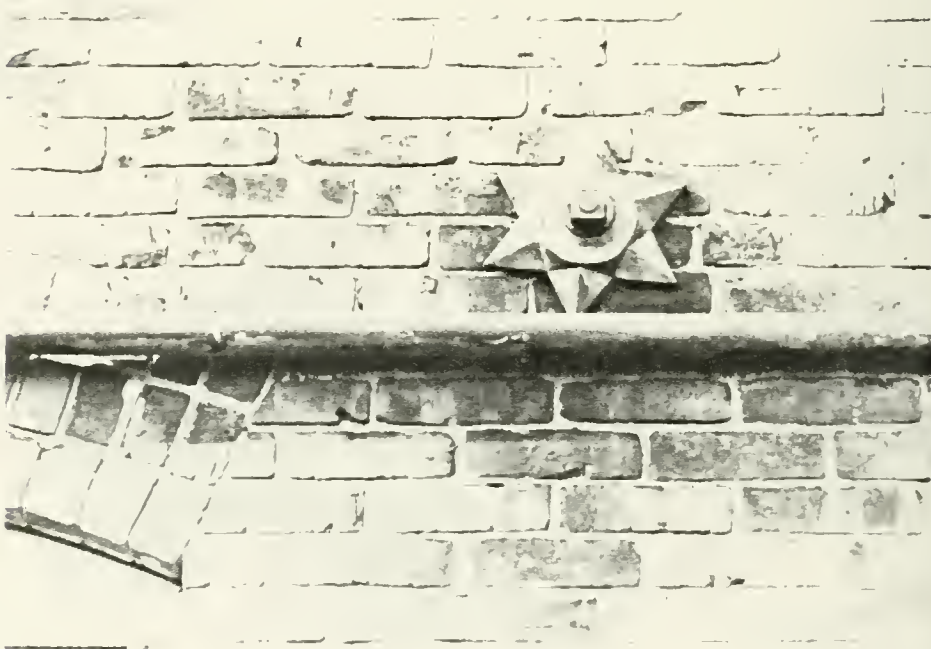
1. Segmentally arched windows and doorways with stone sills.
(Photo # 32)
2. Brick cornice (Photo # 34)
3. 8/8 double hung wooden sash windows. (Photo # 32)
4. Cast iron star shaped wall-tie washers. (Photo # 33)

<u>Area of Work Arranged in Order of Priority; & Photo Key</u>	<u>Estimated Cost</u>	<u>Maintenance & Scheduling</u>
1. Repair & renovate roof and its drainage system, including the roof, wooden & metal gutters, downspouts & drains. (Photo # 34)		B.U.R. good for 20-30 yrs, Paint gutter system 4-6 yrs. Remove leaves & sticks spring & fall
2. Remove all loose, unsound & mismatched mortar & masonry. Repoint, repair & replace as necessary to retain original character. (Photo # 34)		Check & repair 10-15 yrs
3. Renovate windows, making as air tight as possible using weather stripping, reglazing, new glass, etc. Repair weight & pulley system for raising & lowering sashes. Remove unnecessary and unsightly bars & screens. (Photo # 32)		Paint 4-6 yrs Glaze 4-6 yrs Repair as required

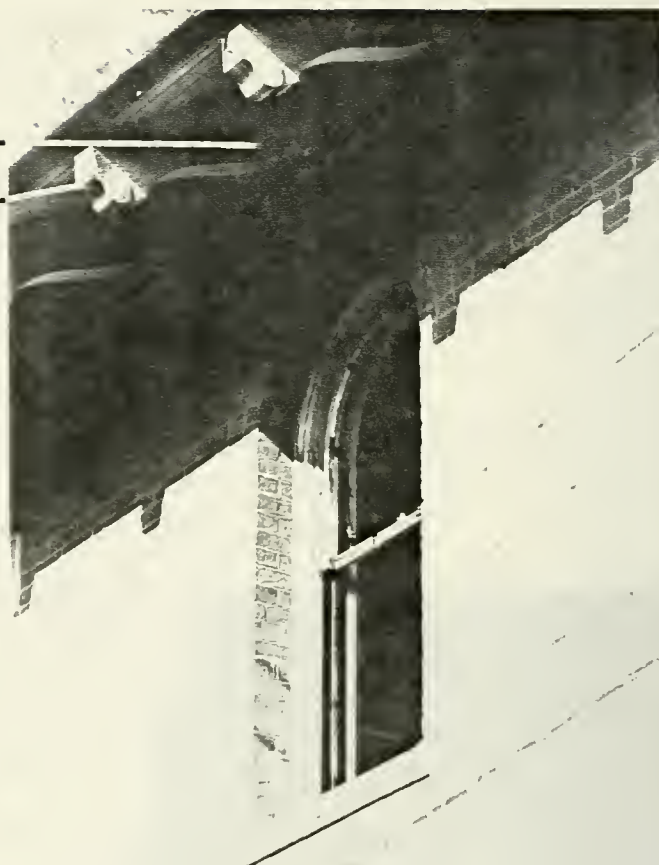
38

Exposed soffit

Ornately sawn rafter-tail

2. Replace all windows with thermal pane, thermal break metal frame units, matching original as closely as possible. This is necessary because most of the existing windows have been damaged beyond repair. (Photos # 38, 39, 40)		Virtually no maintenance on new windows

3. Remove all loose, mismatched & unsound mortar & masonry. Repoint, repair & replace as necessary to retain original character. (Photos # 38, 39, 40, 41)		Inspect & repair, 10-15 yrs

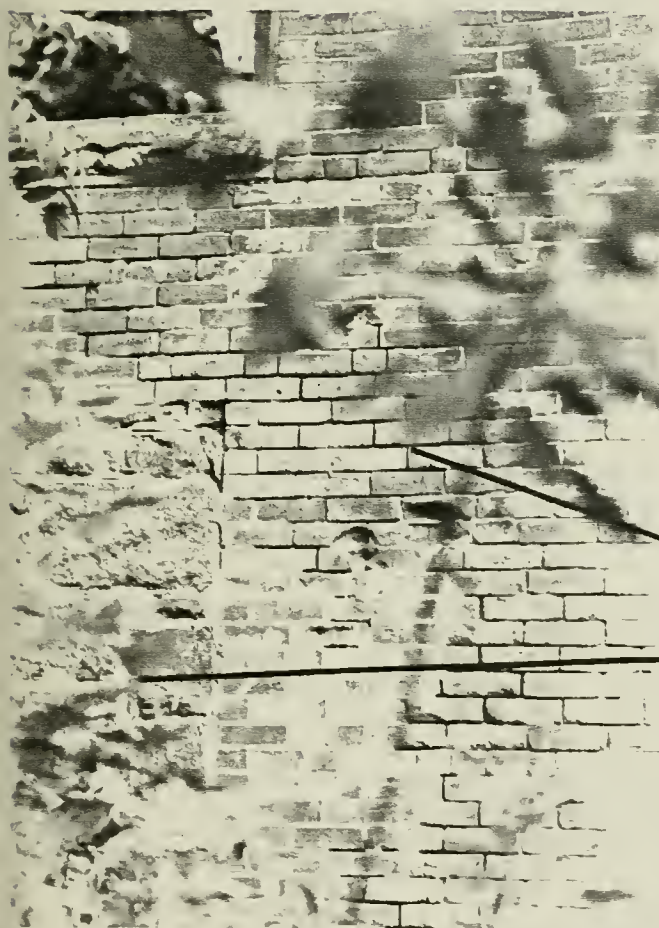
Repoint mortar

Exposed native stone foundation

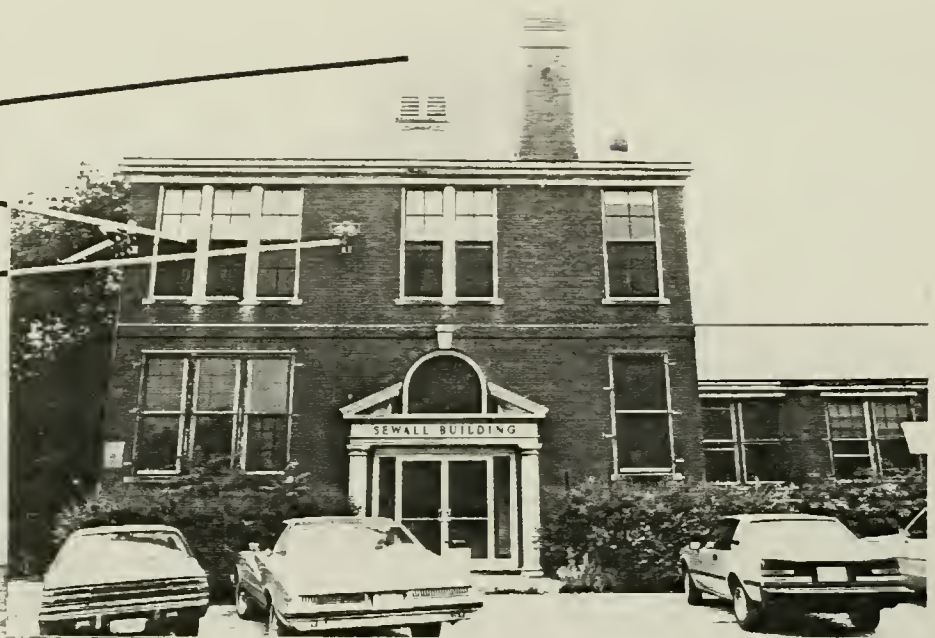
42

4/4 wood sash window

Modern flood lights

3. Inspect all exterior brick walls & chimney surfaces. Remove all loose, mismatched & unsound mortar and masonry. Repoint, repair & replace as needed. (Photos # 42, 43, 45, 46, 47, 49, 50, 53, 55)		Check & repair every 10-15 yrs

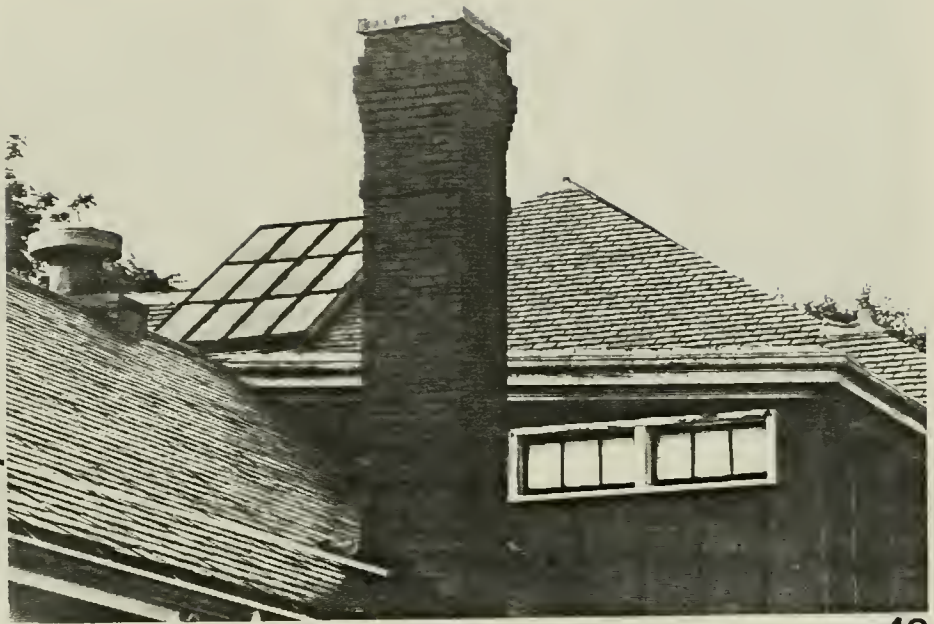
46

Inappropriate mastic covered flashing

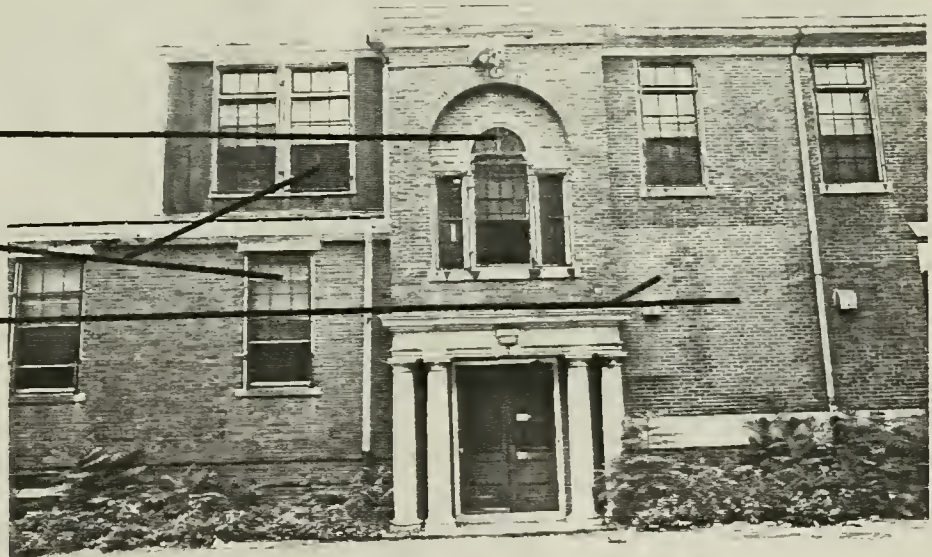
47

Palladian window

Security screens

Bricked-in windows

<u>Area of Work Arranged in Order of Priority; & Photo Key</u>	<u>Estimated Cost</u>	<u>Maintenance & Scheduling</u>
6. Scrape rust and scale from iron railings & repaint with rust inhibiting paint. (Photos # 48, 49, 52, 53, 54, 55)		Check, repair and paint every 4-6 yrs
7. Concrete arcade & its slab roof deck spalling. Repair to maintain structural integrity. (Photo # 52)		Inspect regularly & repair as needed
8. Remove modern floodlights attached to brick walls. (Photos # 42, 43, 47, 50)		N/A
9. Relocate exhaust ducts and vents in bricked up windows on east side. Restore windows to their original locations. (Photo # 47)		Repaint & re-glaze every 4-6 yrs

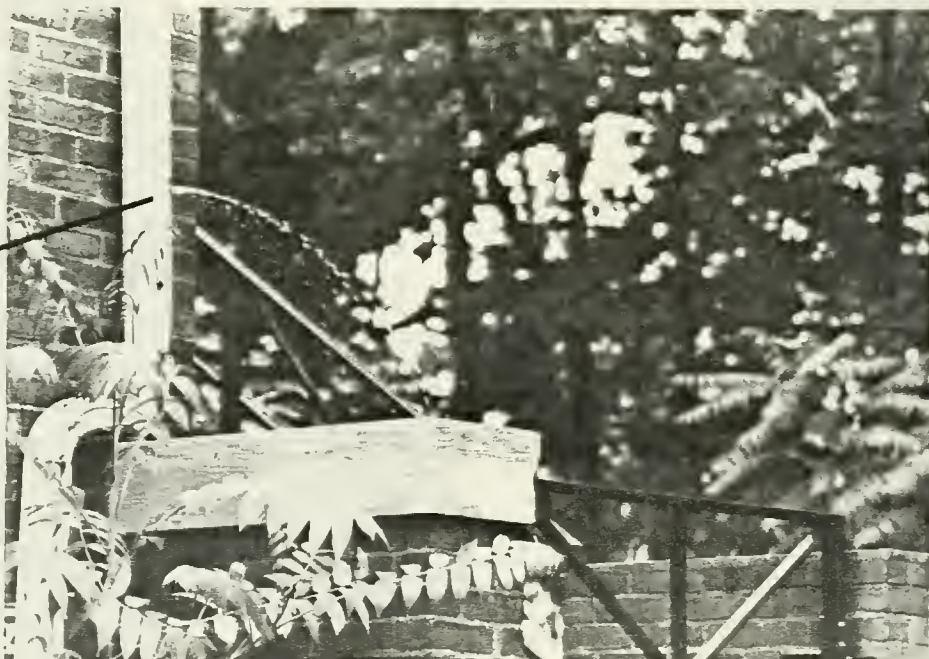
49

Downspout leak

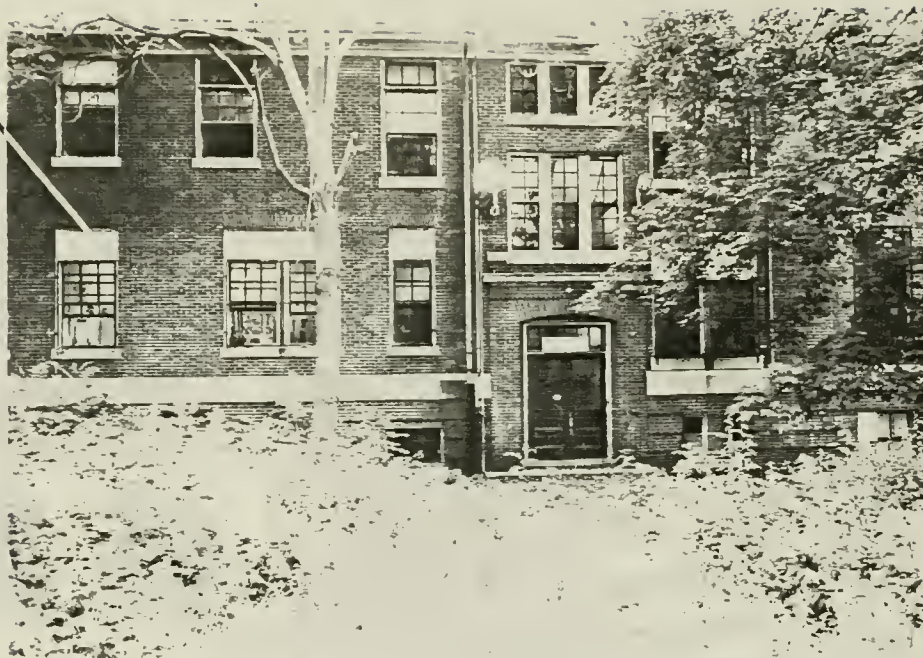
50

boarded in transom windows

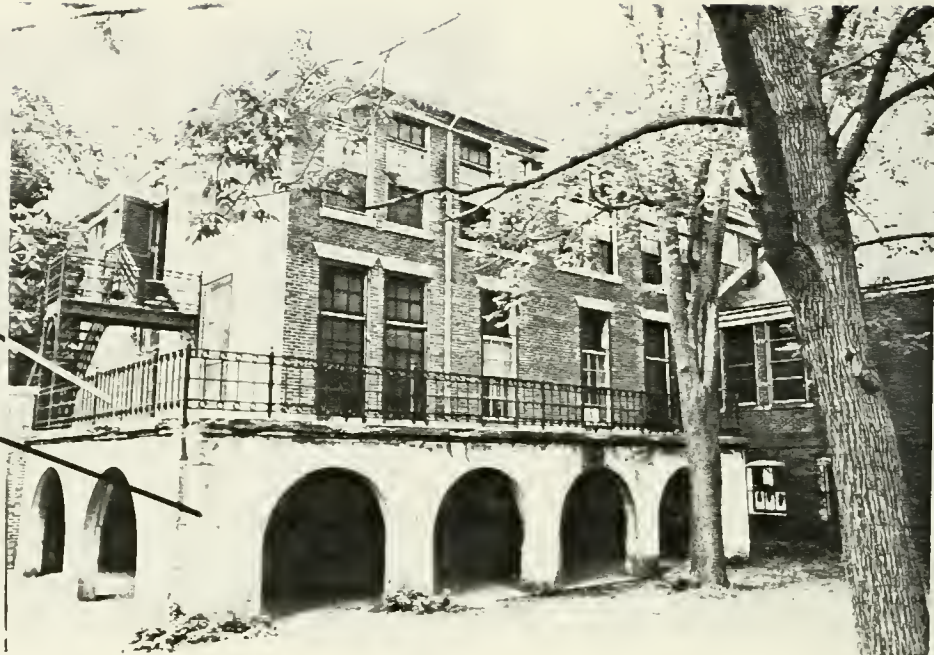
52

Decorative iron rail

Concrete arcade

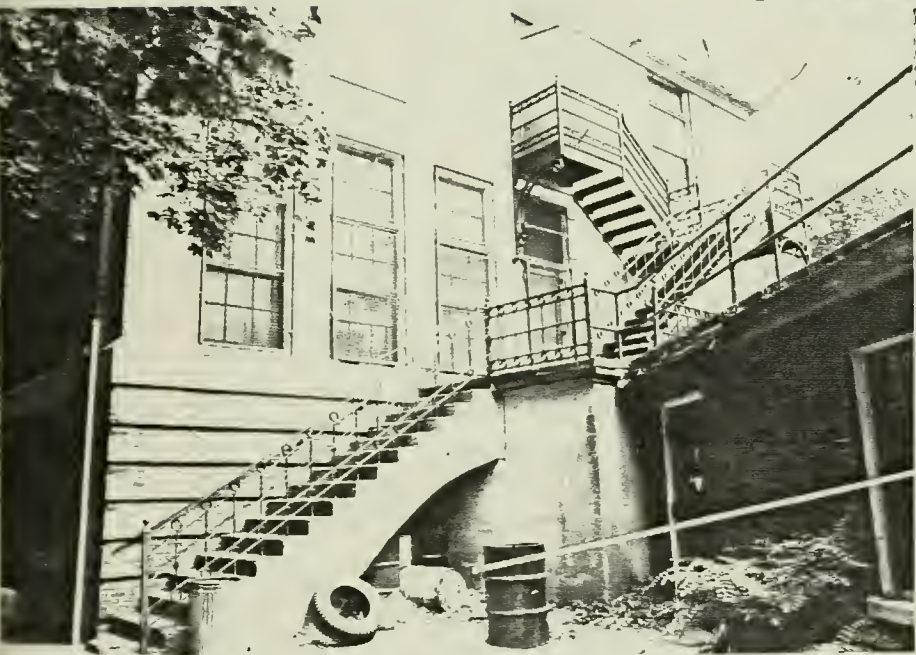
55

Clean up area

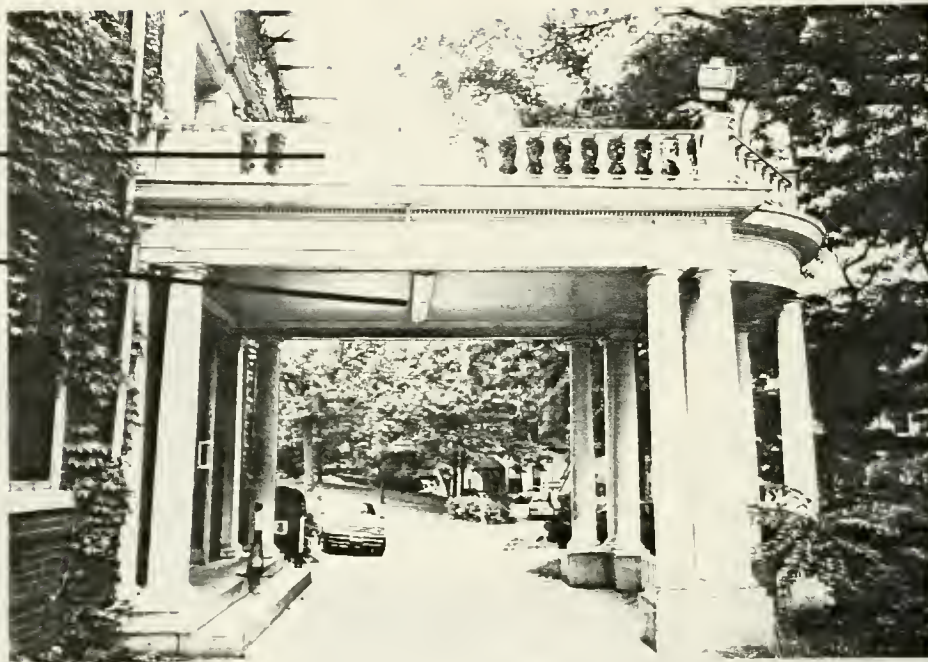
58

Innacurate ballustrade

Flourescent light

10. Restore balustrade to lower wings of buildings. (Photos # 62, 63, 64, 67)		Paint 4-6 yrs
11. Restore porte-cochere. See historic photos for original conditions. (Photos # 56, 57, 58, 61, 62, 66)		Check & clear roof of leaves spring & fall. Paint wood 4-6 yrs

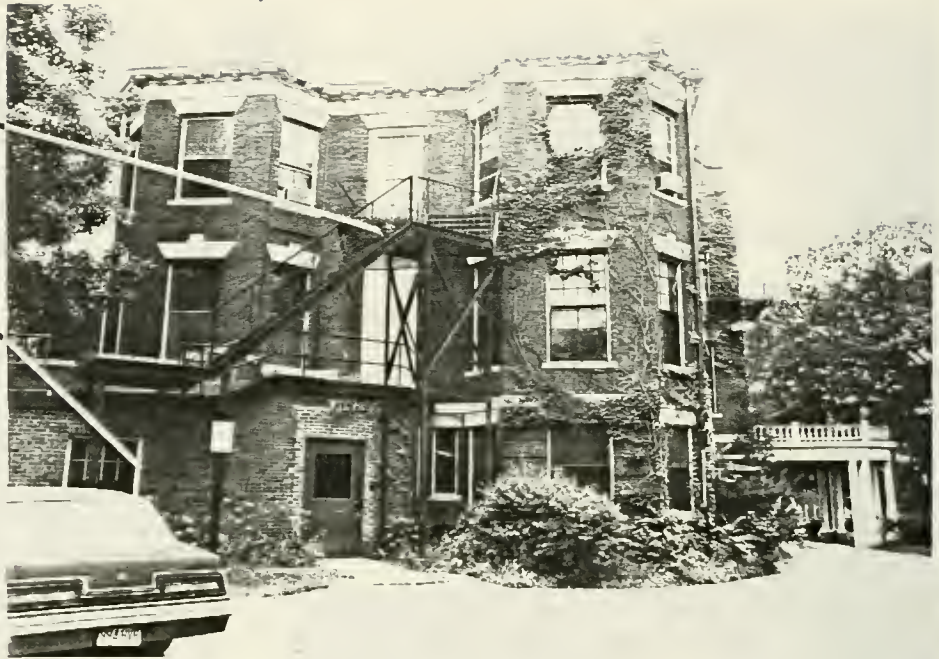
62

Fire escape on north side

Service tunnel to Richards Building

12. Aluminum storm windows & screens should be replaced with less conspicuous protective enclosures. (Photos # 62, 63)		Depends on system - wood needs paint every 4-6 yrs, aluminum virtually maintenance free

13. Scale down fire escape on north side. (Photo # 62)		See #7

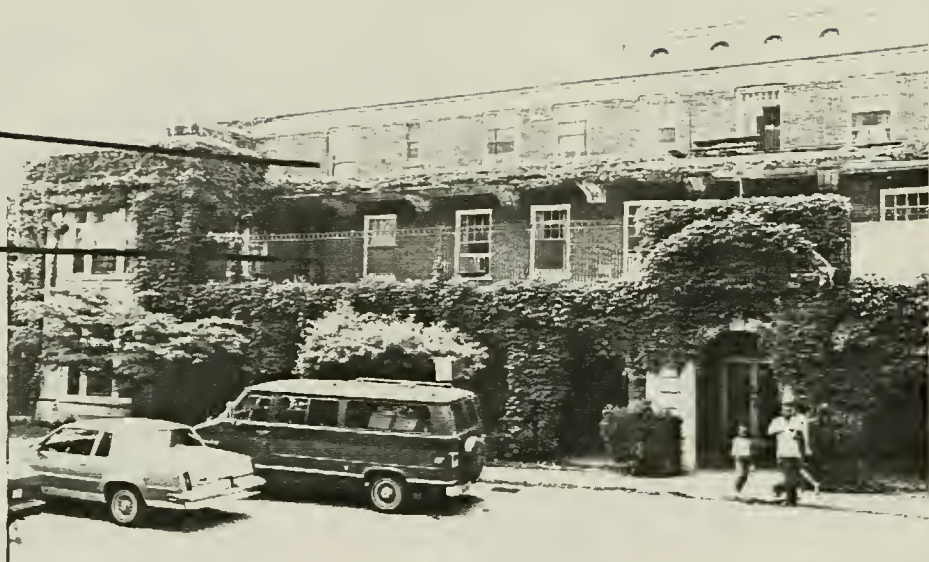
74

Top level sun deck with
iron handrail

2nd floor sun deck with
iron handrail

Penthouse

Cast stone entablature

Main entry center of
arcaded loggia

7. Replace modern aluminum & glass front entrance with door and/or side-lights which duplicate the original in design, material & hardware. (Photos # 74, 75)		See # 3

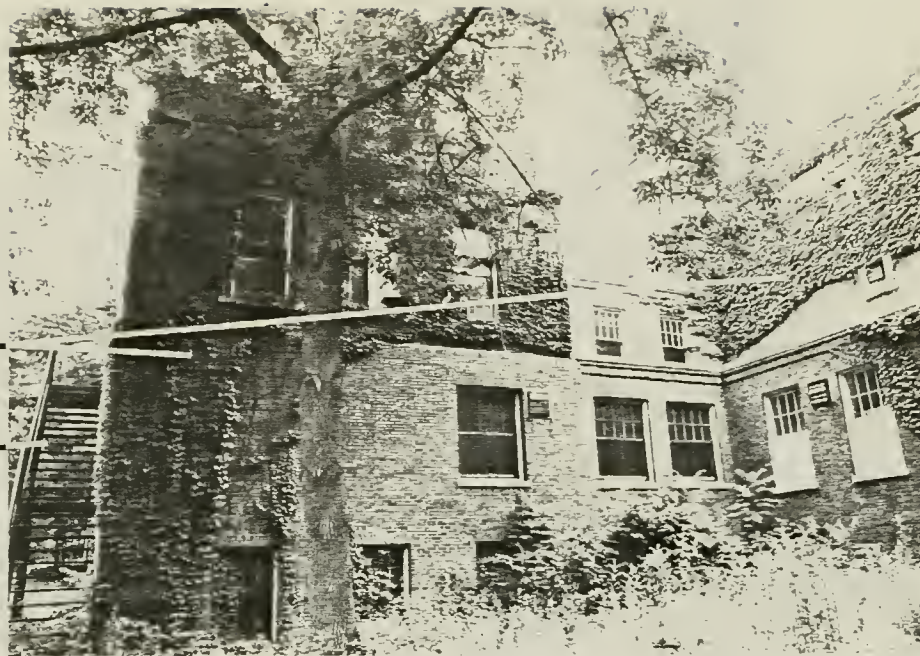
78

vy

fire escape

<u>Area of Work Arranged in Order of Priority; & Photo Key</u>	<u>Estimated Cost</u>	<u>Maintenance & Scheduling</u>
1. Brick & mortar in several areas are in severe need of restoration. Remove all loose, mismatched & unsound mortar & masonry from exterior walls. Repoint, repair & replace as required to maintain a moisture resistant surface. (Photos # 76, 78, 79, 82, 85, 86)		Inspect & repair every 10-15 yrs

2. Utilities hardware & hook-ups not currently in use should be removed from all exterior wall surfaces. (Photo # 85)		See # 1
3. Inappropriate aluminum framed awning windows have replaced original, wooden double hung sash windows. Restore to original condition. Reduce air infiltration with weather stripping, new caulking, reglazing & sill repair. (Photos # 77, 78, 79, 84)		Paint every 4-6 yrs

8. Security bars & screens should be removed where possible & replaced with a less visible form of barrier if still necessary. (Photos # 77, 78, 84, 85)		N/A

9. Fire escape repair, maintenance, painting. (Photos # 78, 79, 82, 83, 84)		Regular maintenance for safe & proper working conditions. Scrape & paint every 4-6 yrs

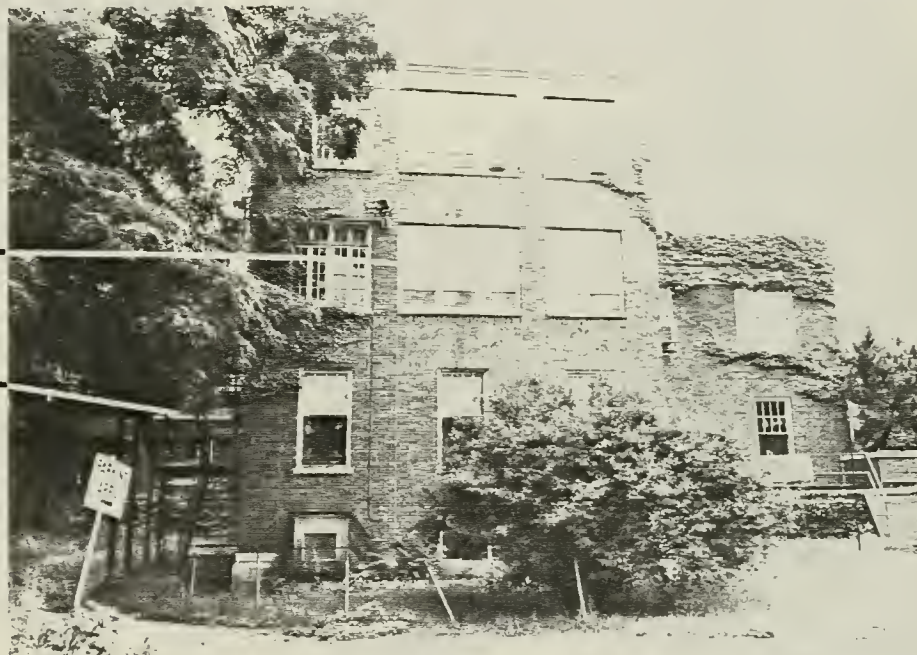
79

aluminum awning windows

fire escape

<u>Area of Work Arranged in Order of Priority; & Photo Key</u>	<u>Estimated Cost</u>	<u>Maintenance & Scheduling</u>
5. All exterior wood surfaces need repair, restoration or replacement; then scraped, sanded & painted. (Photos # 76, 77, 79, 83, 84, 85)		See # 3

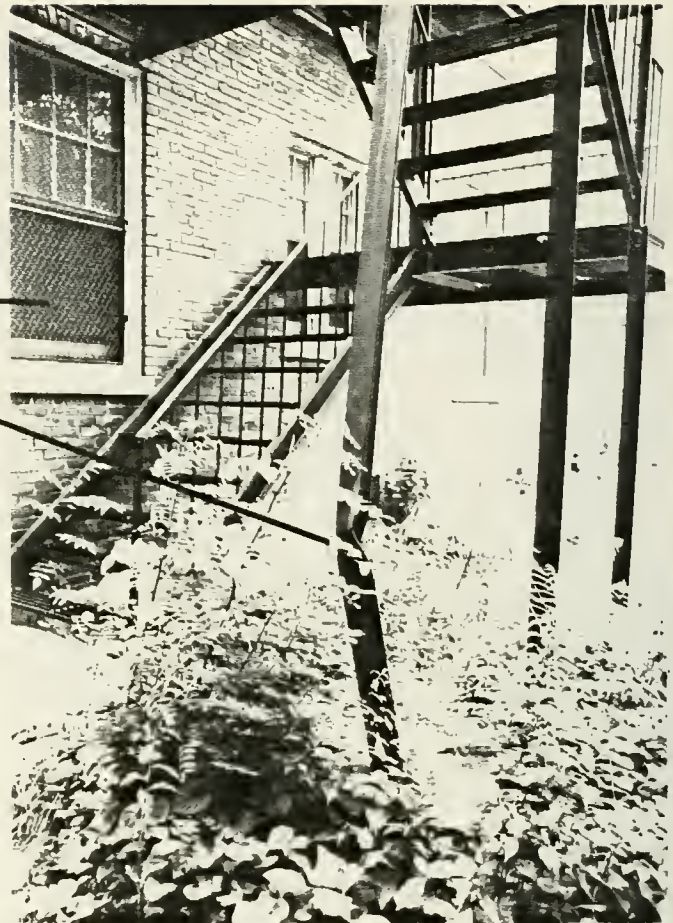
84

Security screen

Damaged fire escape structural

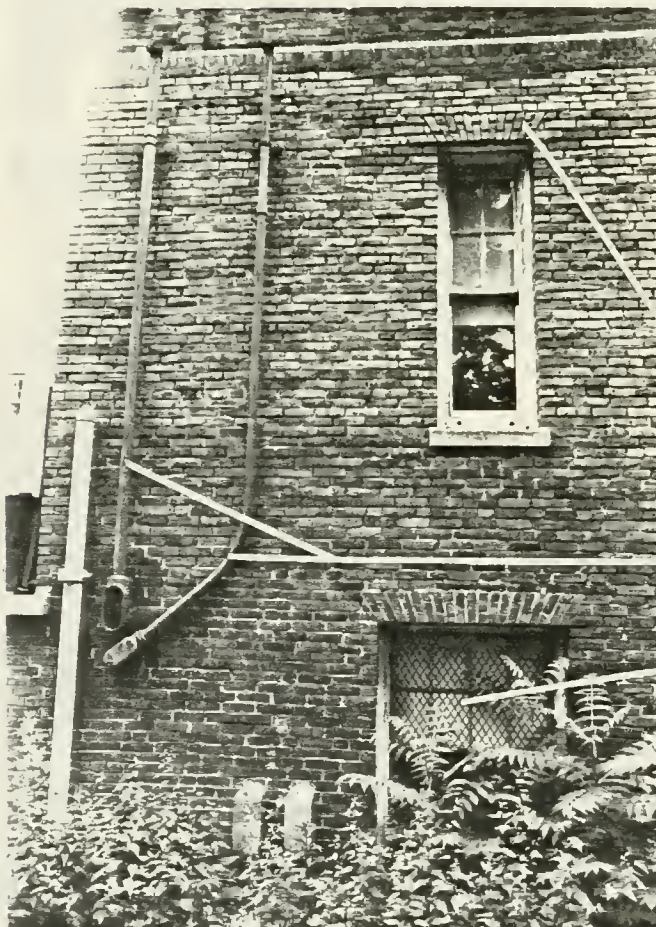
85

Flared lintel

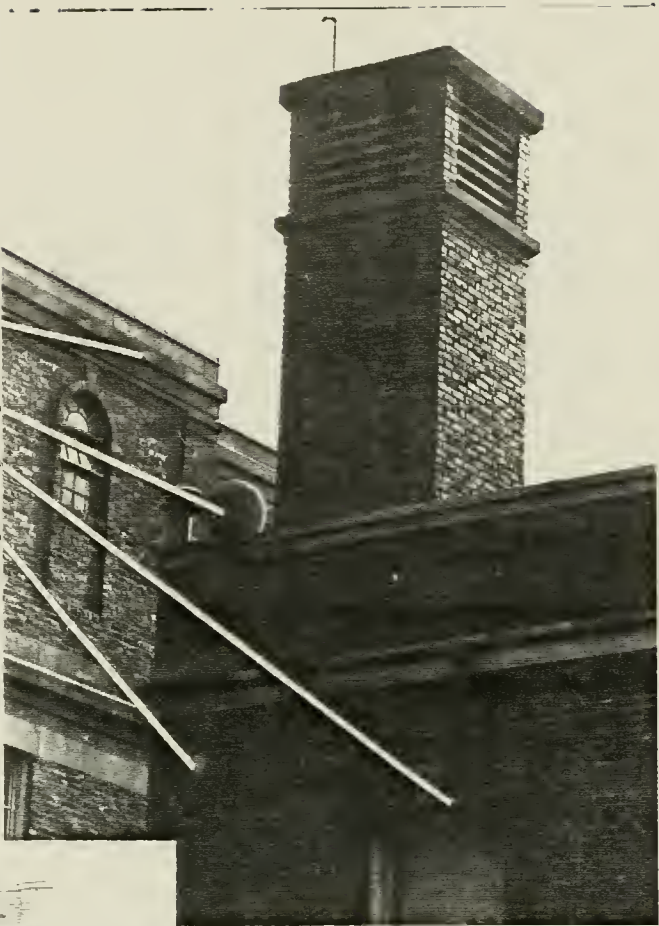
86

Penthouse

Decorative cast stone pieces

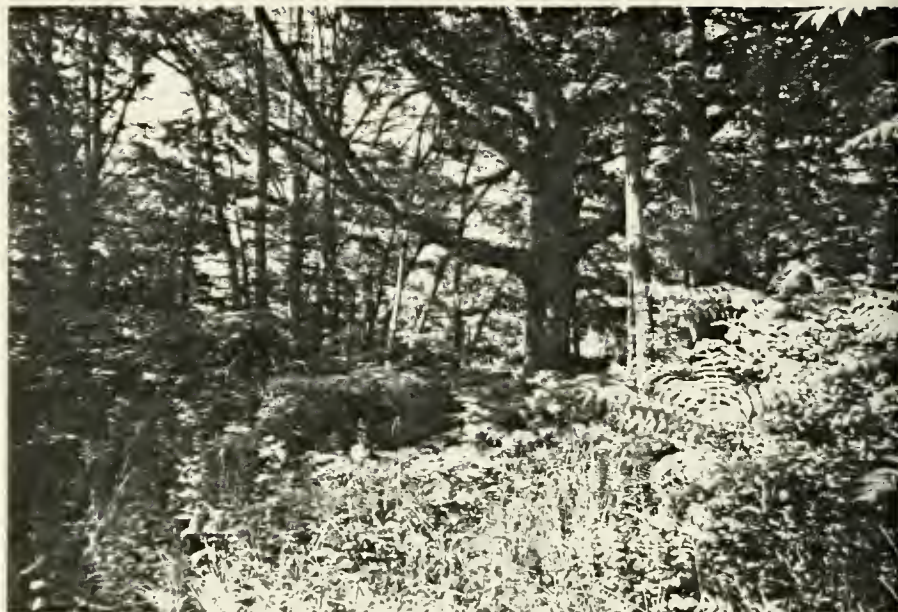
88

Nice deciduous planting, adequate summer screening of views into the site as well as from the parking area. Needs evergreen planting for year-round coverage. (Rhododendron, Ilex, Hemlock, Taxus, etc.)

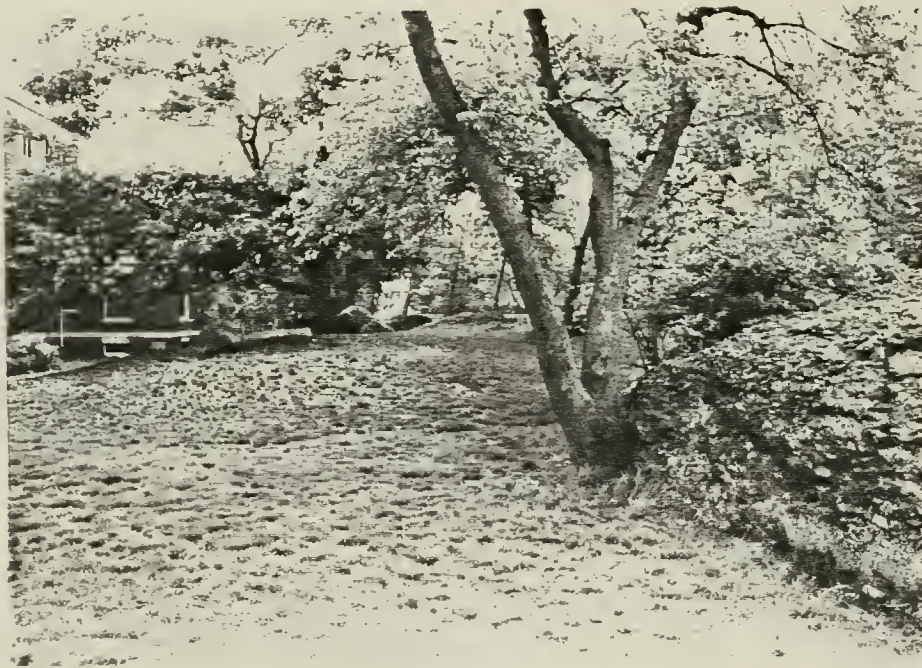
91

Replace grass with
groundcover massings
(vinca minor, pachy-
sandra) for better
coverage and reduced
maintenance.

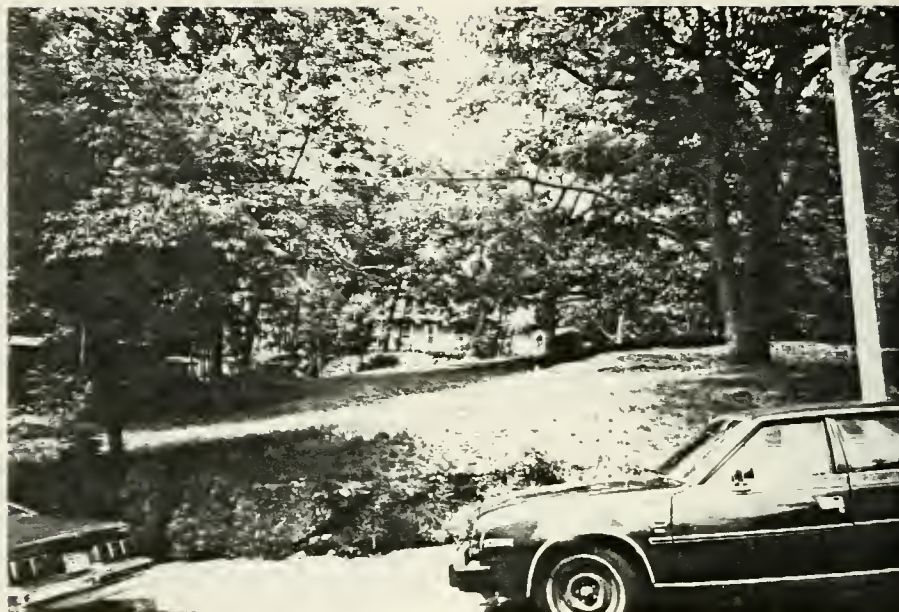
96

This view through the outcrop area could be just as nice as the view (11) across the road given the proper maintenance, i.e. trimmed edges.
